PROYECTO FINAL DE CARRERA

Patología estructural y del casco:

Métodos de protección, inspección, mantenimiento y reparación

Ingeniería Naval y Oceánica
Junio, 2014

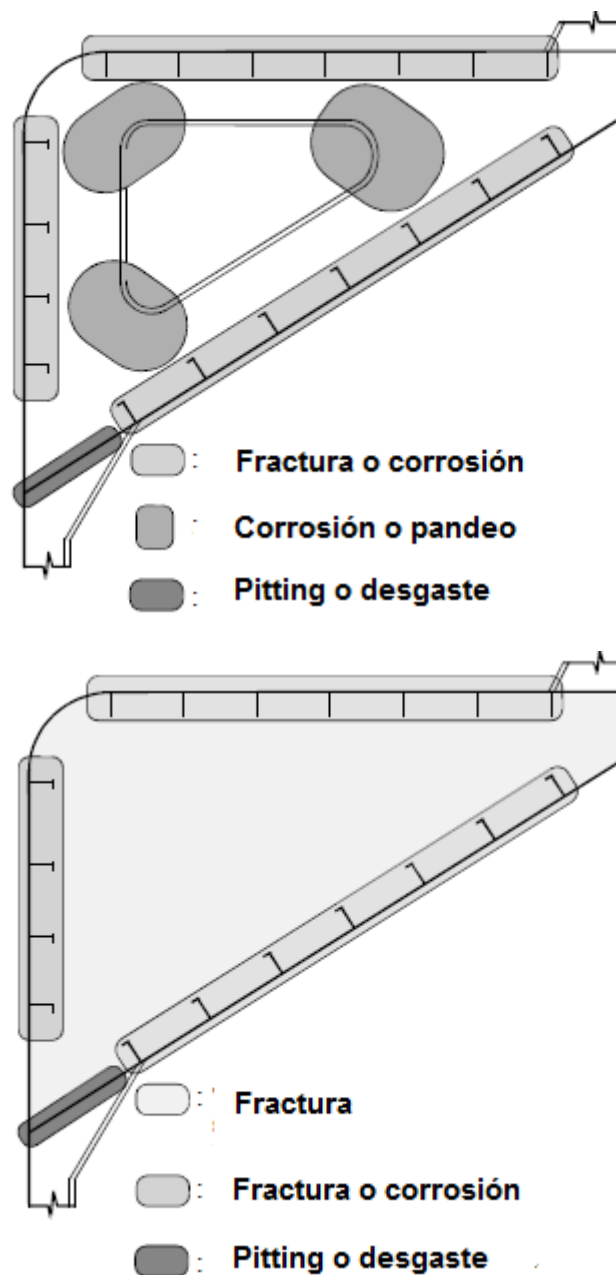
- Estructura de la unión cubierta-costado
 - Áreas adyacentes a los aligeramientos sin reforzar
 - Consolas de refuerzo
 - Refuerzos transversales
 - Refuerzos longitudinales
 - Zonas adyacentes al mamparo de colisión
 - Zonas adyacentes al mamparo de la Cámara de Máquinas

Figura 8.6: Estructura de unión costado-cubierta

Figura 8.6: Estructura de unión costado-cubierta – Pg 99

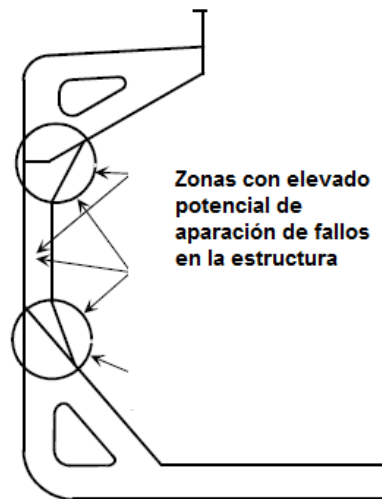
- Estructura del costado
 - Planchas de costado
 - Unión entre la estructura de cubierta o de fondo y la estructura lateral
 - Planchas cercanas al mamparo de colisión
 - Planchas cercanas al mamparo de Cámara de Máquinas

Figura 8.7: Estructura de costado

Figura 8.7: Estructura de costado – Pg 100

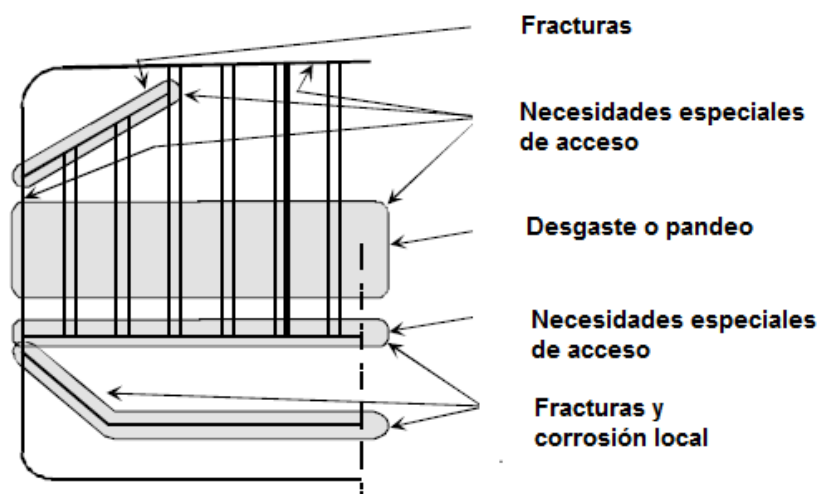
- Mamparos transversales
 - Uniones soldadas entre los mamparos y la estructura del buque
 - Zonas adyacentes a los límites de la estructura lateral
 - Mamparos corrugados
 - Consolas de refuerzo

Figura 8.8: Mamparo transversal

Figura 8.8: Mamparo transversal – Pg 100

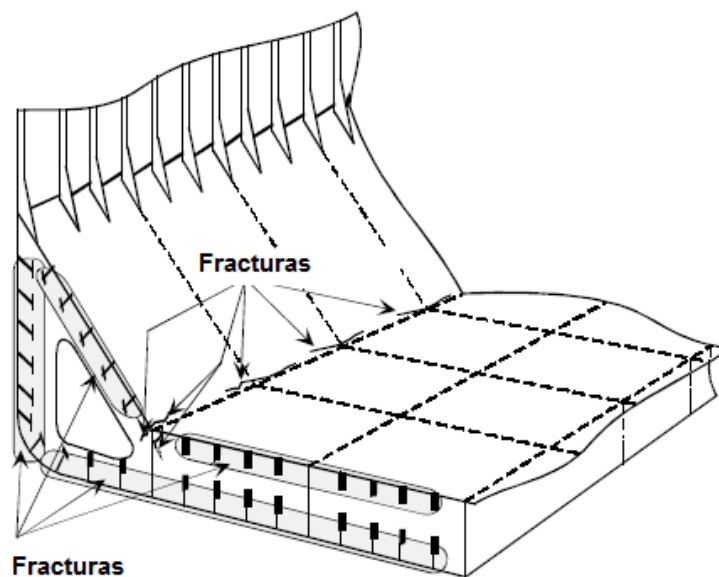
- Doble fondo
 - Planchas en el fondo de la zona de carga
 - Zonas adyacentes a los aligeramientos en la eslora
 - Uniones soldadas
 - Intersecciones entre refuerzos
 - Unión entre el fondo y los mamparos
 - Planchas del doble fondo situadas a proa del buque debido a daños causado por el slamming
 - Planchas adyacentes a la quilla

Figura 8.9: Estructura del doble fondo

Figura 8.9: Estructura de doble fondo – Pg 101

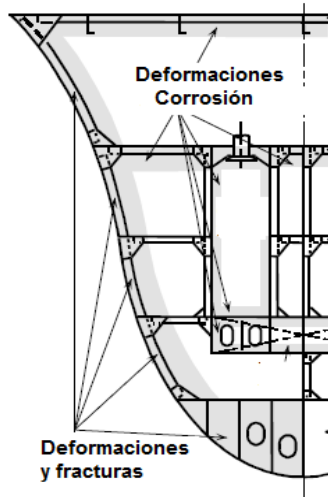
- Zona de proa
 - Planchas de cubierta
 - Planchas adyacentes al rompeolas
 - Planchas y refuerzos de la zona de la caja de cadenas
 - Zona del castillo de proa
 - Unión de refuerzos

Figura 8.10: Estructura del pique de proa

Figura 8.10: Estructura de pique de proa – Pg 102

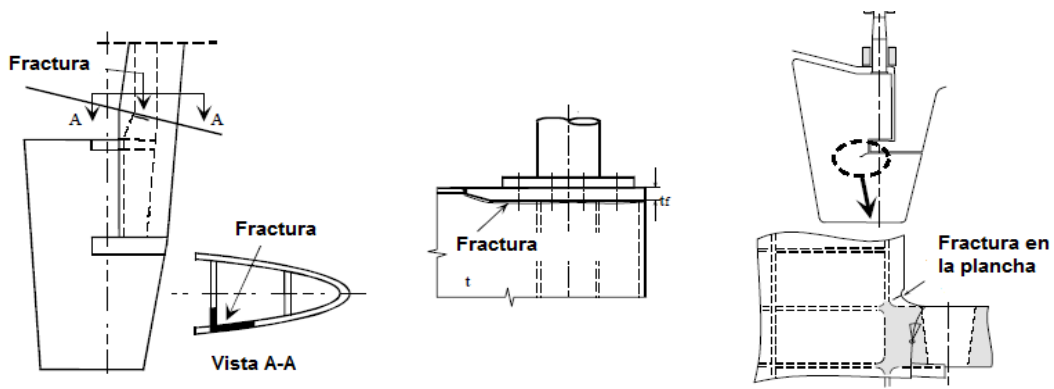
- Zona del timón y de la hélice
 - Zona del pinzote del timón
 - Zona de la zapata del codaste
 - Acople del timón con la mecha
 - Zona de la bocina de la hélice

Figura 8.11: Timón

Figura 8.11: Timón – Pg 102

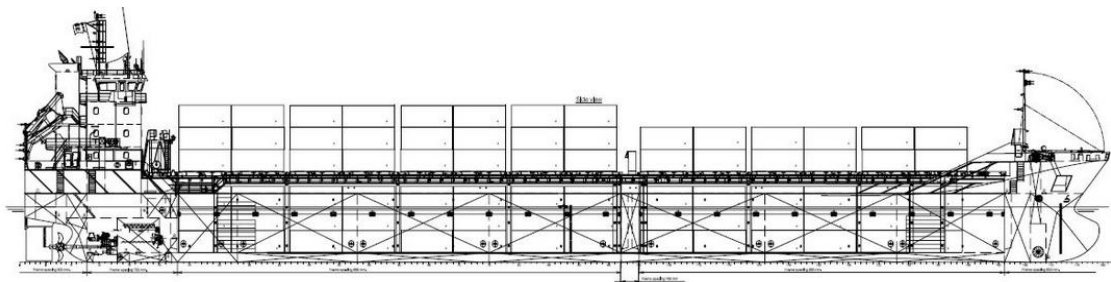
Figura 8.12: Buque portacontenedores

Figura 8.12: Buque portacontenedores – Pg 103

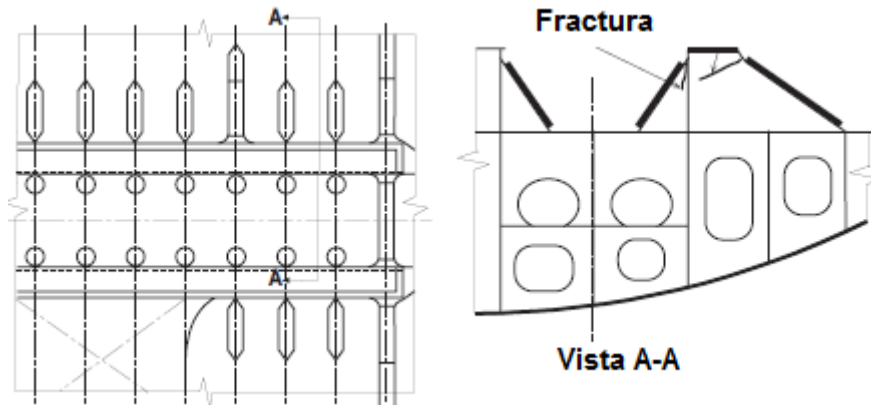
- Planchas contiguas a los tanques de almacenamiento
- Tubos y tuberías que atraviesan las planchas o mamparos
- Base estructural de los motores principales

Figura 8.15: Base estructural de los motores principales en la CM

Figura 8.15: Base estructural de los motores principales en la CM – Pg 106

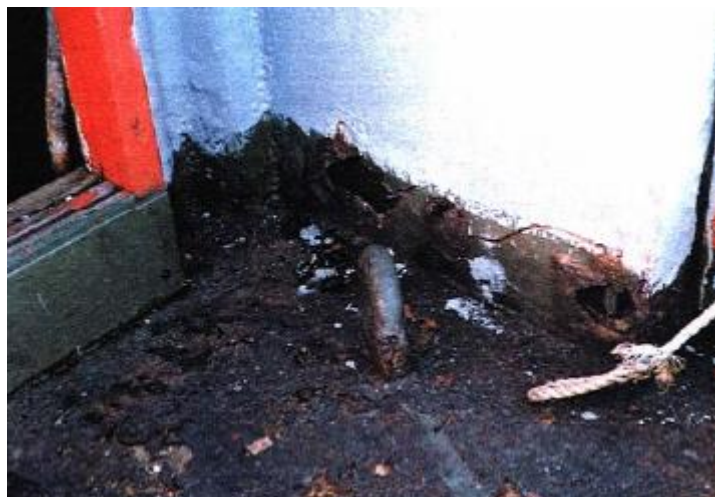
- Problemas de corrosión en toda la zona de alojamiento y en las cubiertas de la superestructura

Figura 8.16: Problemas de corrosión en la zona de alojamiento

Figura 8.16: Problemas de corrosión en la zona de alojamiento – Pg 106

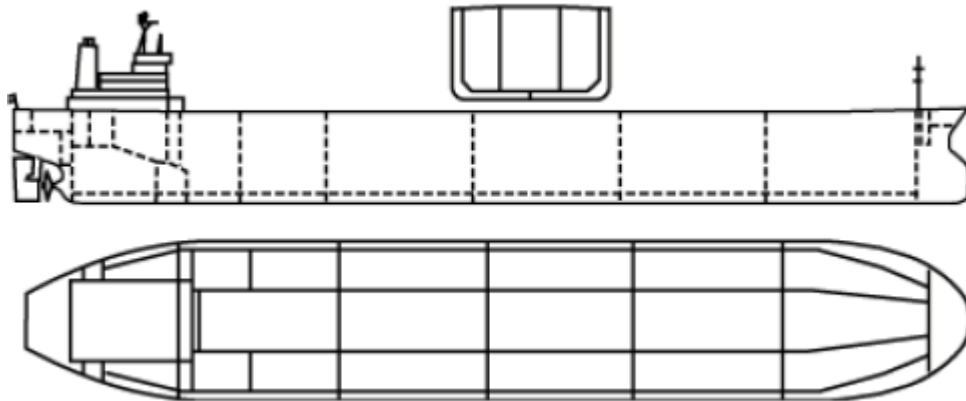
Figura 8.17: Buque petrolero

Figura 8.17: Buque petrolero – Pg 107

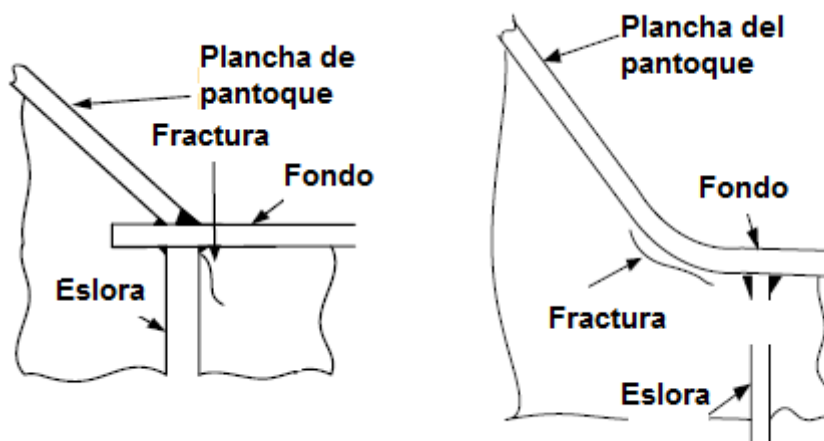
- Plancha de unión entre el fondo y los refuerzos
- Unión entre el pantoque y el fondo
- Unión entre las esloras del buque y la plancha del fondo
- Plancha del pantoque
- Refuerzos y sus uniones en las zonas de pantoque

Figura 8.18: Zona de unión del pantoque con el fondo

Figura 8.18: Zona de unión del pantoque con el fondo – Pg 107

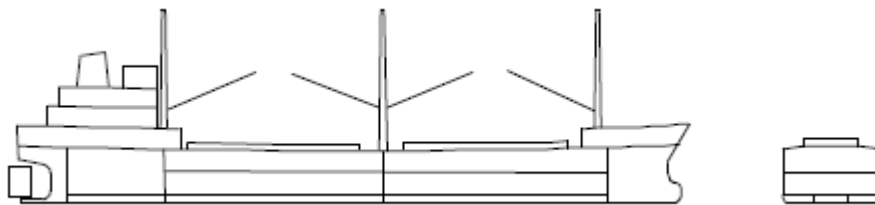
Figura 8.21: Buque de carga general

Figura 8.21: Buque de carga general – Pg 110

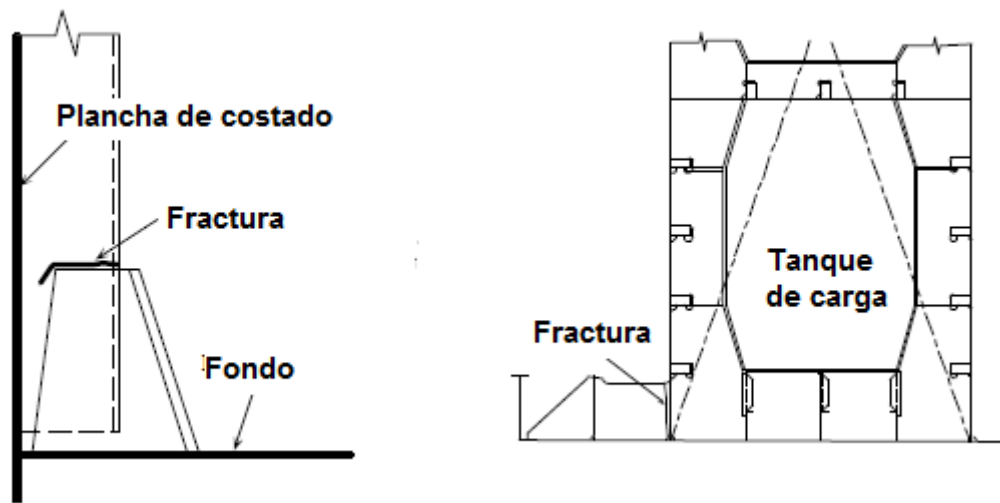
- Estructura de costado
 - Unión del costado con los refuerzos inferiores del pantoque
 - Zonas adyacentes a los tanques superiores
 - Zonas entre bodegas de carga
 - Refuerzos próximos al mamparo de colisión, así como sus planchas asociadas
 - Refuerzos al fondo de los tanques de carga

Figura 8.22: Ejemplos de fractura en la estructura de costado

Figura 8.22: Ejemplos de fractura en la estructura de costado – Pg 111

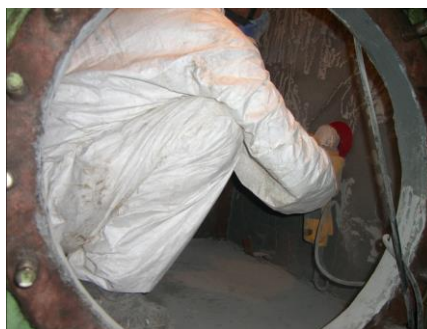
Para la ejecución de las labores de mantenimiento se efectuará la inspección del estado del recubrimiento en función del plan de mantenimiento estipulado. Y en caso de que sea necesaria un repintado de los mismos, se procederá a remover el recubrimiento dañado y preparar la superficie para la posterior aplicación del nuevo recubrimiento, mediante los métodos explicados en el capítulo 6.

Figura 9.1: Proceso de eliminación del recubrimiento dañado

Figura 9.1: Proceso de eliminación del recubrimiento dañado – Pg 119

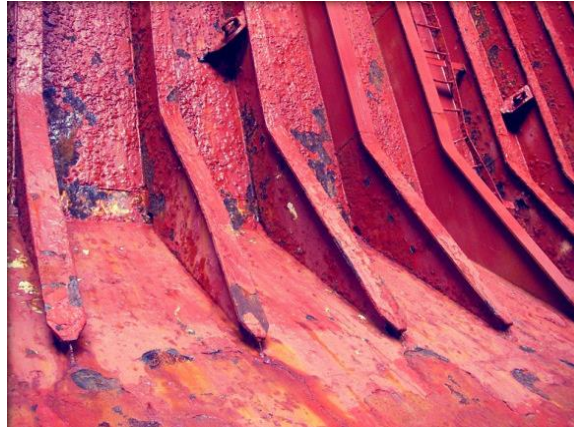
El pitting se puede encontrar generalmente en superficies horizontales internas, normalmente en las planchas de fondo de los tanques de carga o de lastre. Si se encuentra dispersado puede que no afecte de manera muy significativa a la resistencia estructural del buque. Sin embargo, teniendo en cuenta la velocidad de deterioro que tiene y la profundidad a la que se puede extender, puede llegar a ocasionar problemas estructurales a tener en cuenta.

Figura 9.2: Ejemplo de pitting en la estructura de los tanques de carga

Figura 9.2: Ejemplo de pitting en la estructura de los tanques de carga – Pg 120

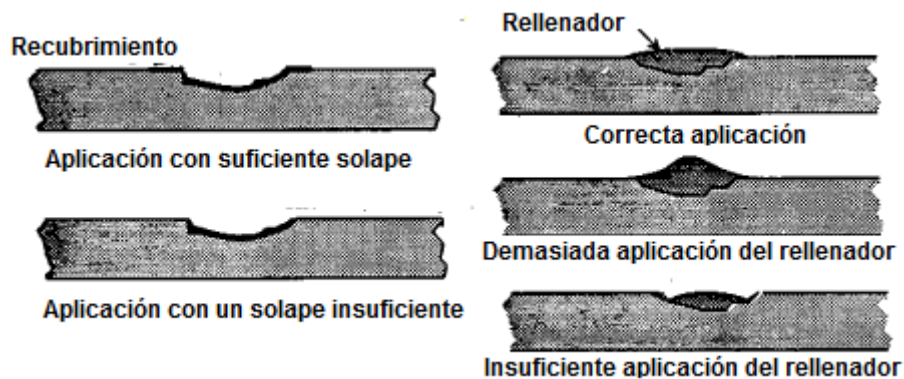
1. Si el espesor remanente de la plancha es mayor al espesor definido, se va a proceder a aplicar un método abrasivo de limpieza para eliminar el pitting y después aplicar un nuevo recubrimiento sobre éste mediante el uso de brocha; o bien, aplicar un rellenador en las picaduras producidas en el metal.

Figura 9.3: Métodos de reparación mediante abrasión o rellenador

Figura 9.3: Método de reparación mediante abrasión o rellenador – Pg 120

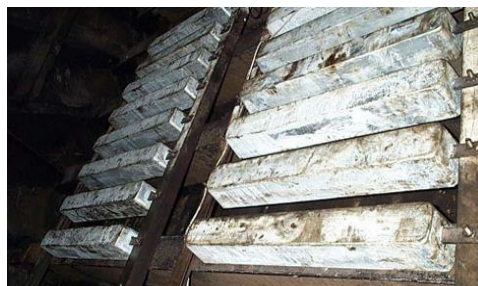
El mantenimiento de los ánodos de sacrificio es un mantenimiento que implica pocas labores y tiempo invertido en él. Básicamente consiste en el seguimiento de su estado de deterioro, y si se encuentra muy deteriorado o se considera necesaria su sustitución, cambiarlo por uno nuevo.

Figura 9.5: Ánodos de sacrificio

Figura 9.5: Ánodos de sacrificio – Pg 121

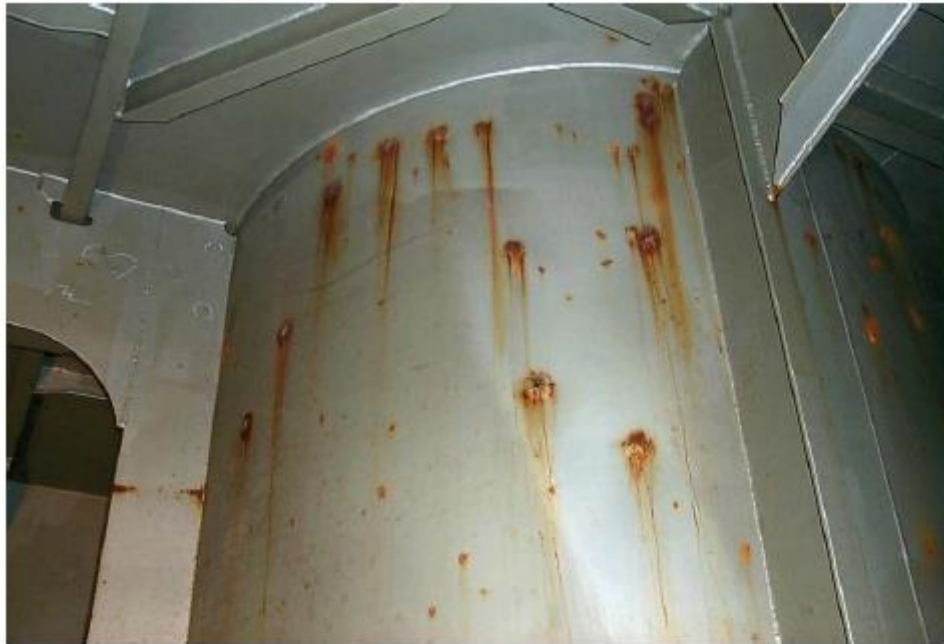
Superficie plana: 1% de deterioro

Comentario: La corrosión en la superficie es menor al 1%

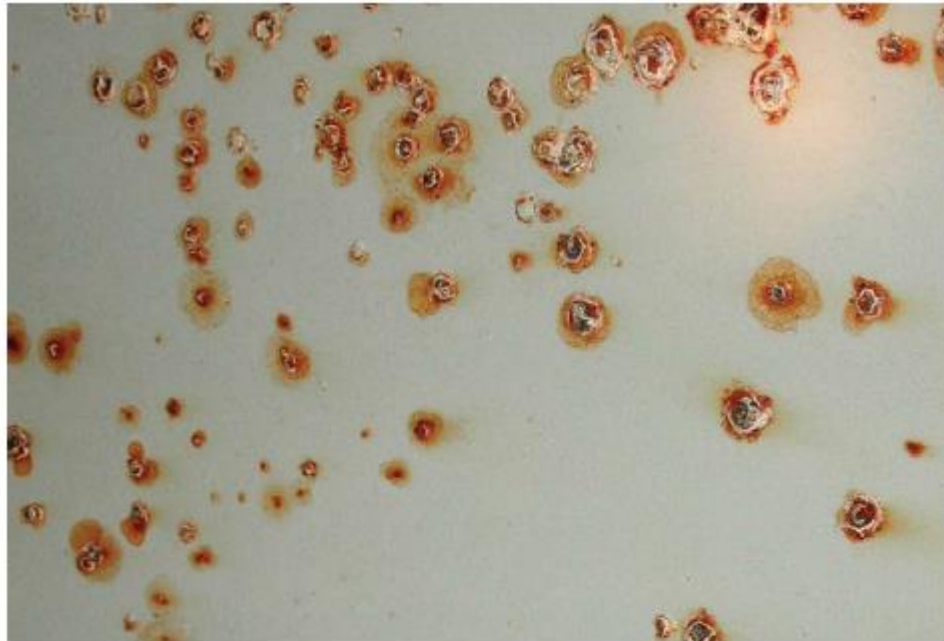
Superficie plana: 5% de deterioro

Comentario: Las manchas de herrumbre no se consideran

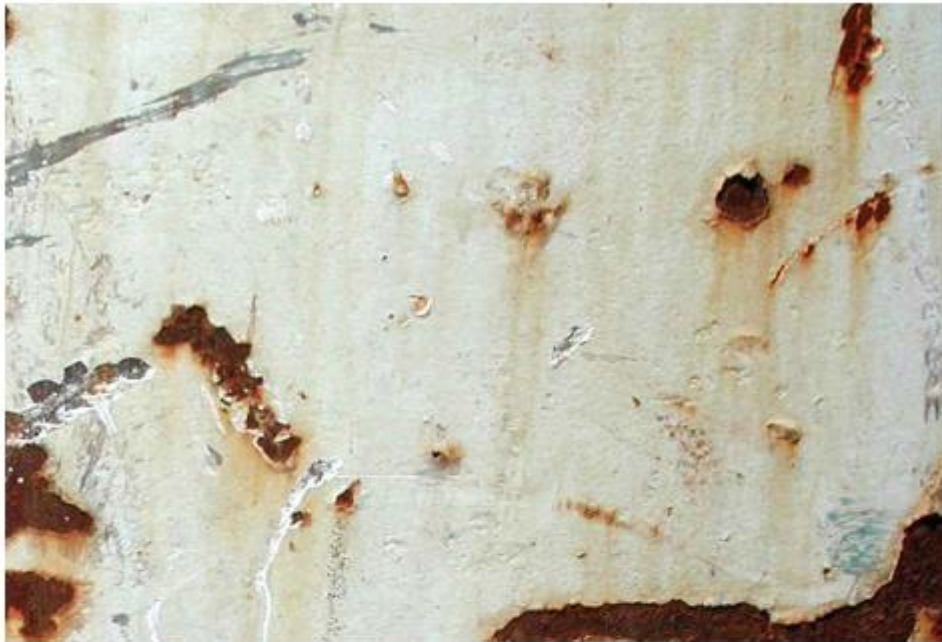
Superficie plana: 10% de deterioro

Comentario: Corrosión del 10%

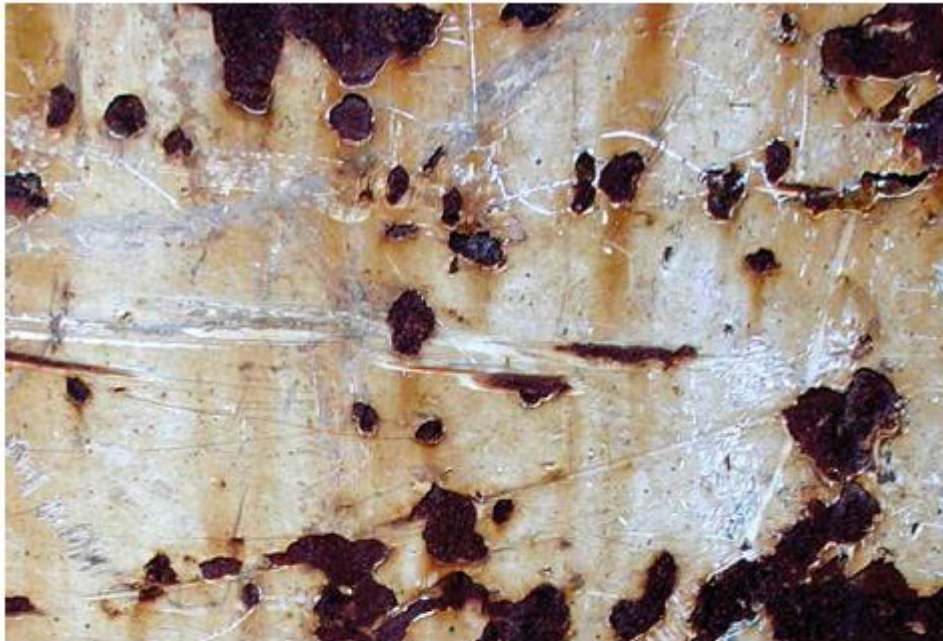
Superficie plana: 1% de rotura

Comentario: Corrosión del 25% e incrustaciones menores al 10%

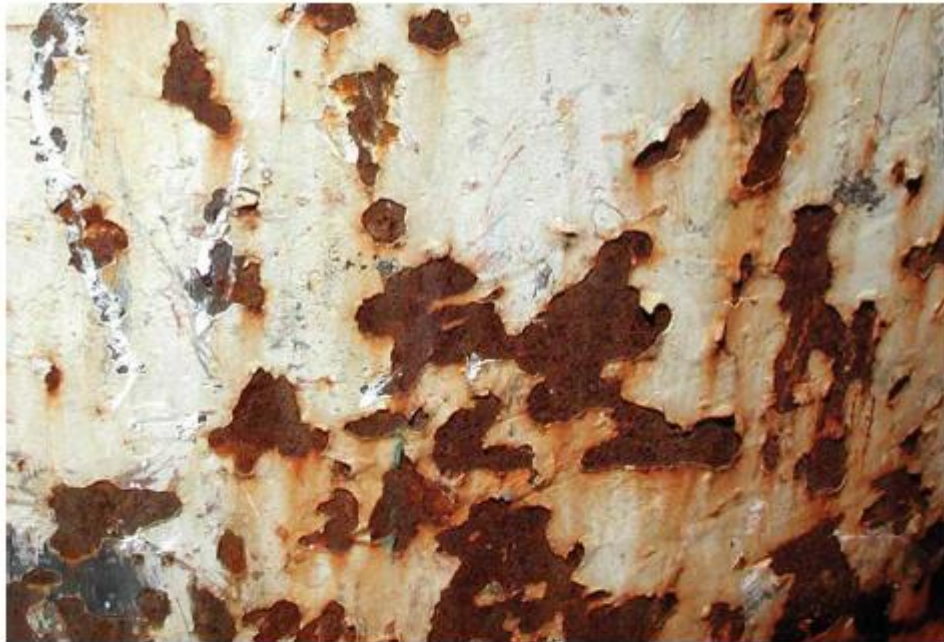
Superficie plana: 33% de deterioro

Comentario: Corrosión mayor al 30%

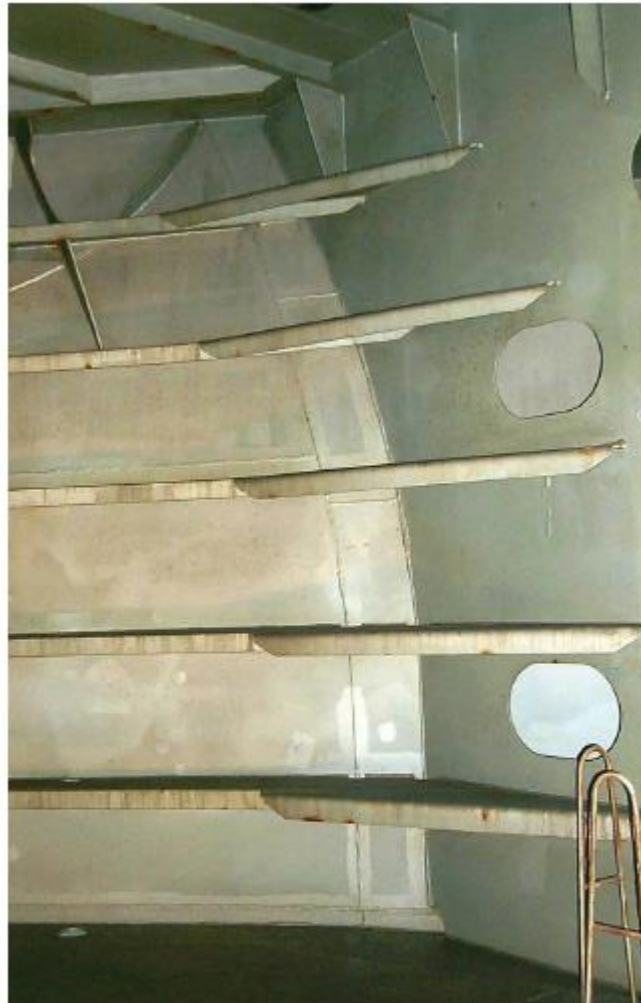
Bordes/Soldaduras: deterioro del 5%

Comentario: Corrosión en bordes y soldaduras menor al 5%

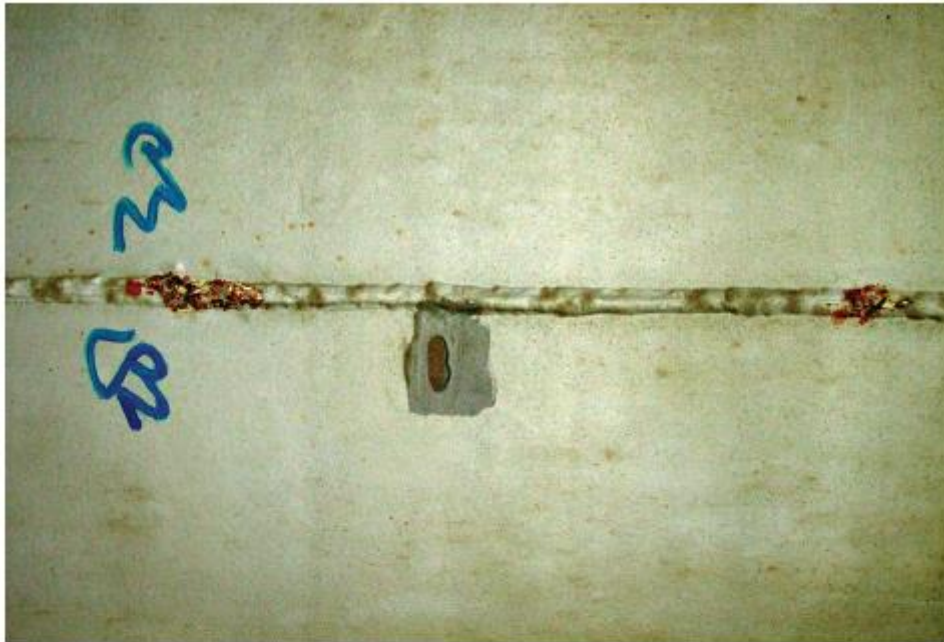
Soldaduras: deterioro del 10%

Comentario: Corrosión en bordes y soldaduras menor al 10%

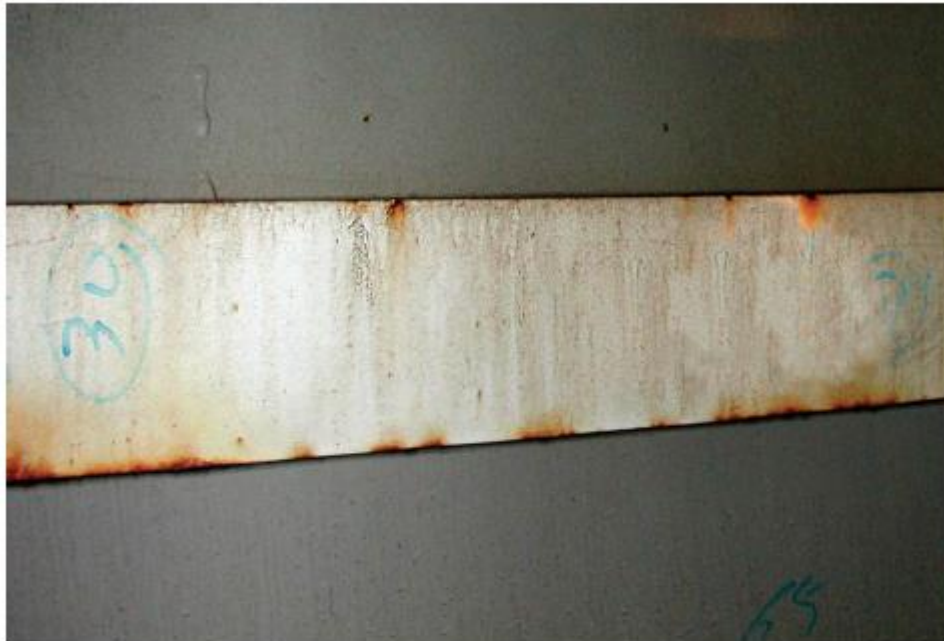
Bordes: deterioro del 10%

Comentario: Corrosión en bordes y soldaduras menor al 10%

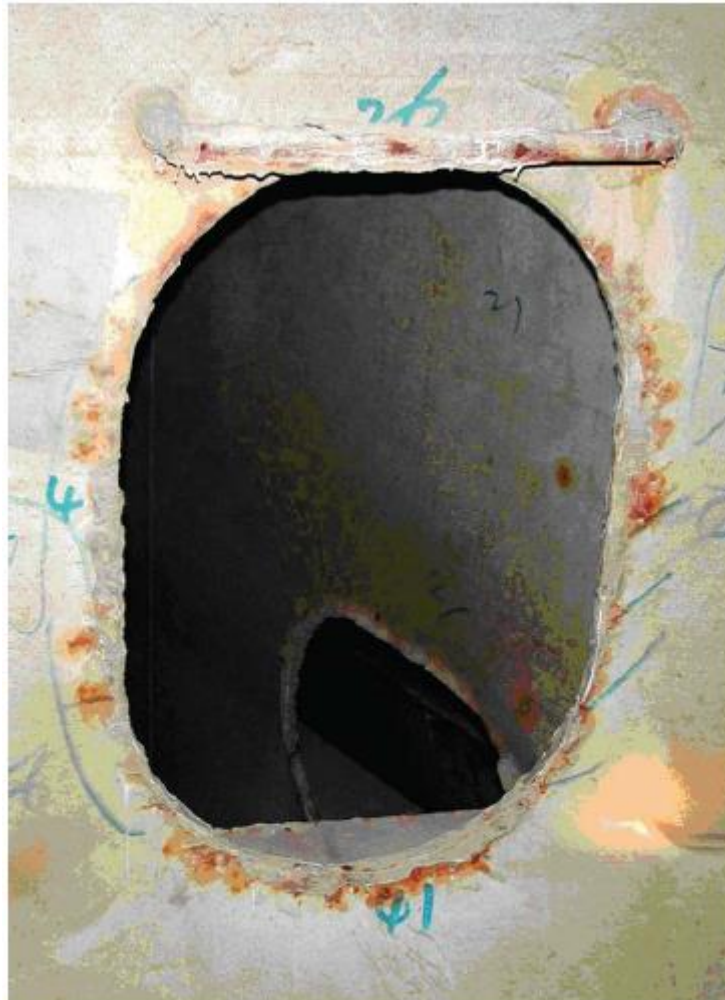
Bordes: deterioro del 50%

Comentario: La condición en función de las reglas IMO depende de la condición de las superficies planas adyacentes.

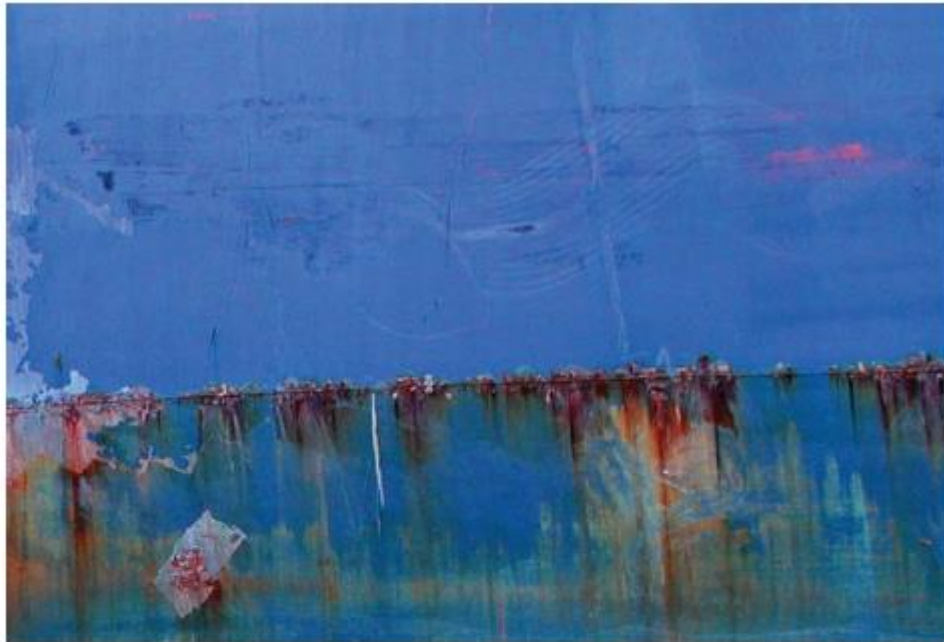
Soldaduras: 80% de deterioro

Comentario: La condición en función de las reglas IMO depende de la condición de las superficies planas adyacentes.

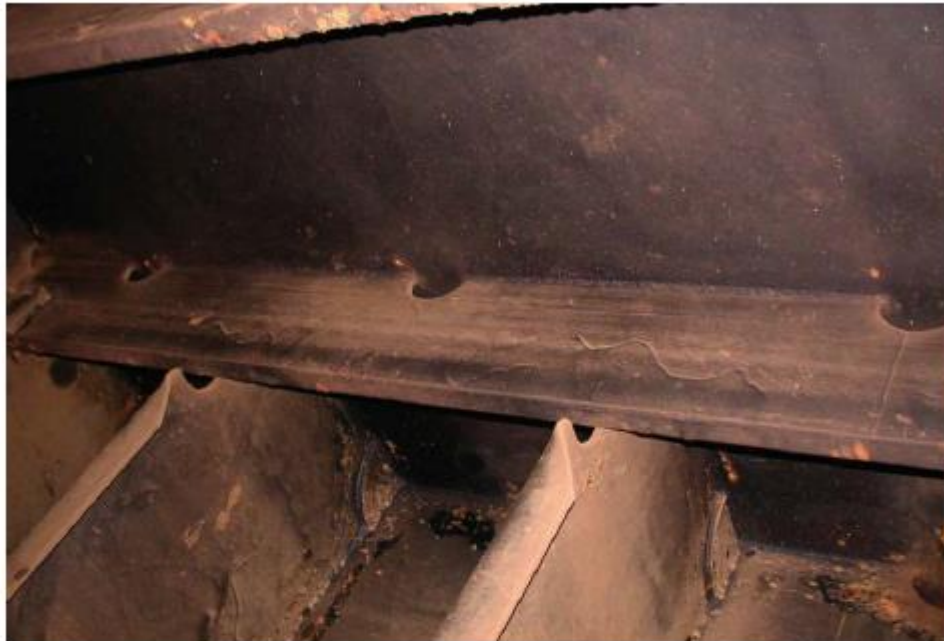
Epoxi en buena condición

Comentario: Corrosión en superficies planas menor al 1% y menor al 5% en bordes y soldaduras

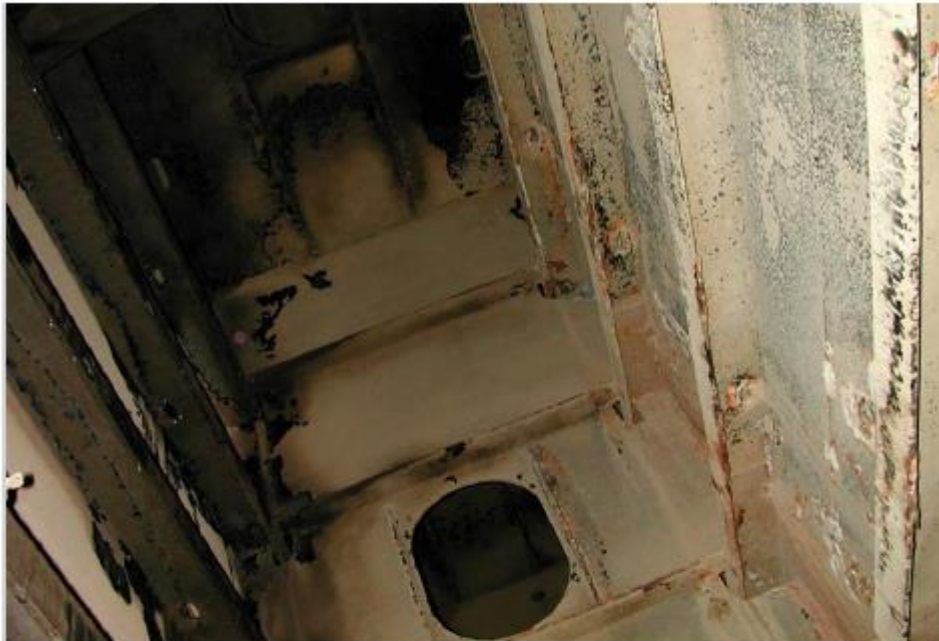
Epoxi en tanques de lastre en buena condición

Comentario: Corrosión en superficies planas menor al 1% y menor al 5% en bordes y soldaduras

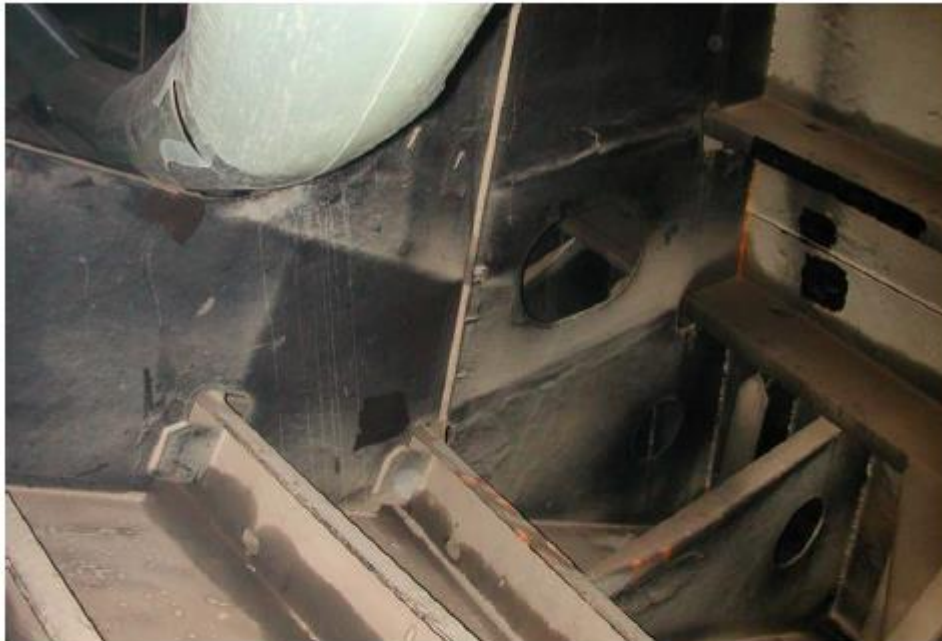
Epoxi en tanques de lastre en buena condición

Comentario: Corrosión en superficies planas menor al 1% y menor al 5% en bordes y soldaduras

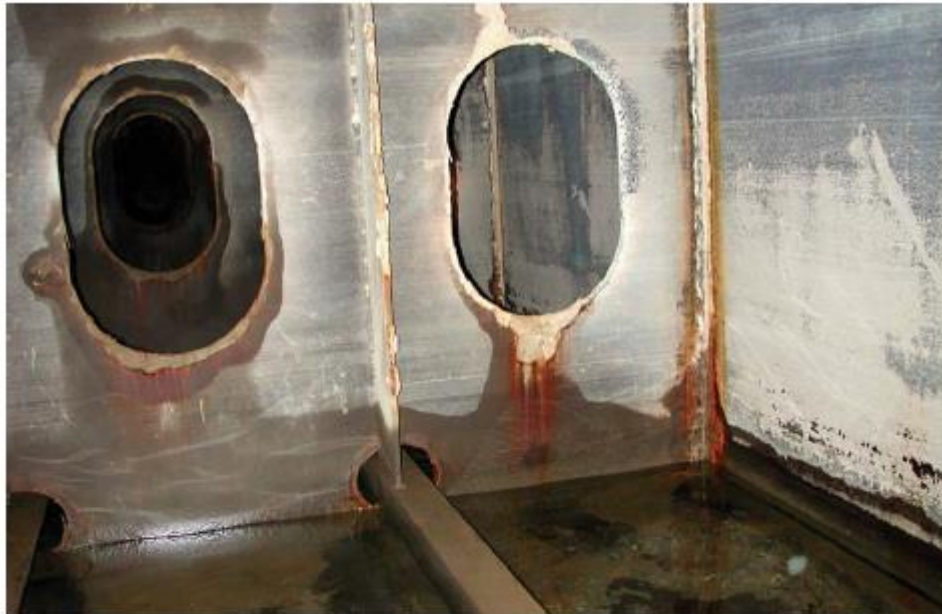
Epoxi en condición aceptable/buena

Comentario: Corrosión en superficies planas menor al 1% y de entre el 20% y 50% en los bordes y soldaduras

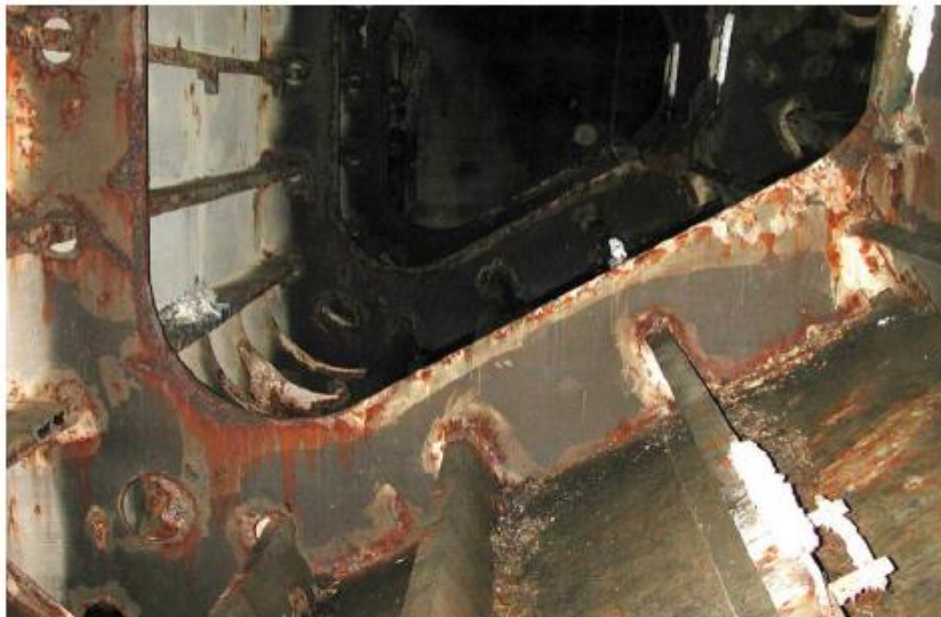
Epoxi en condición aceptable/desfavorable

Comentario: Corrosión en superficies planas menor al 5% y del 40% en los bordes y soldaduras

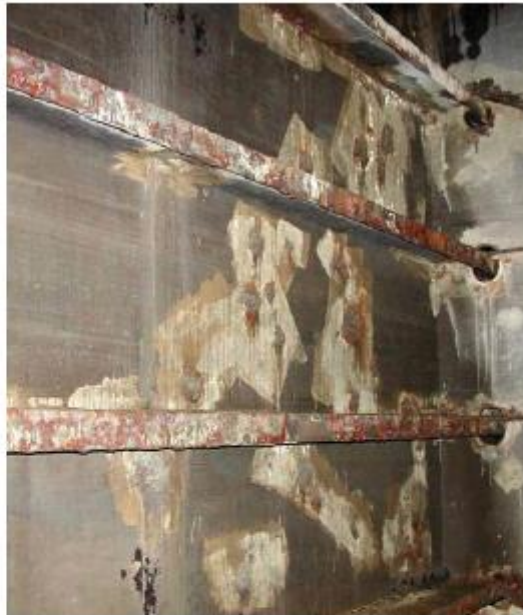
Epoxi en tanques de lastre en una condició acceptable

Comentario: Corrosión en superficies planas menor al 5% y mayor al 50% en los bordes y soldaduras

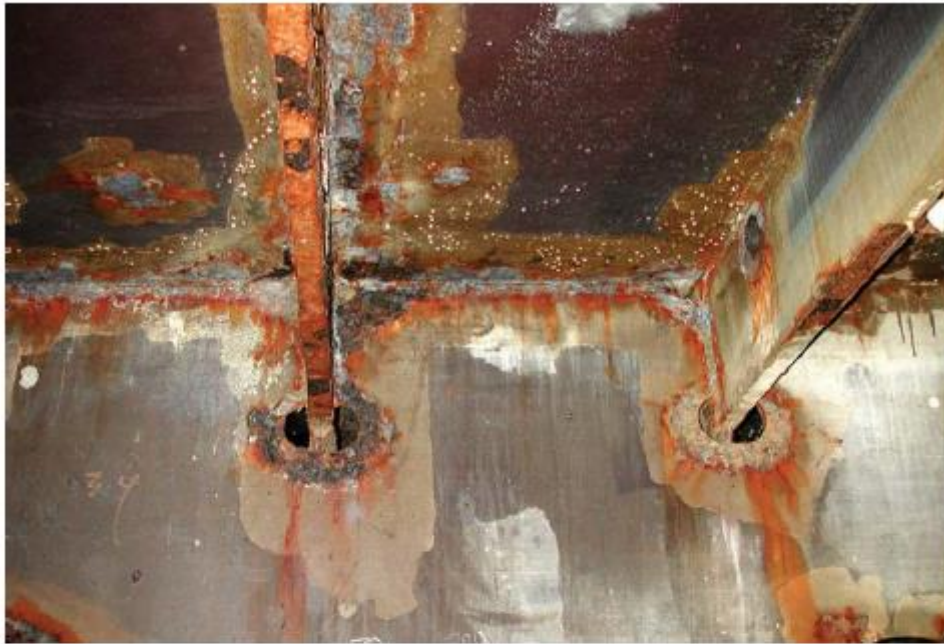
Epoxi en tanques de lastre en una condició desfavorable

Comentario: Corrosión en superficies planas menor al 5% y mayor al 80% en los bordes y soldaduras

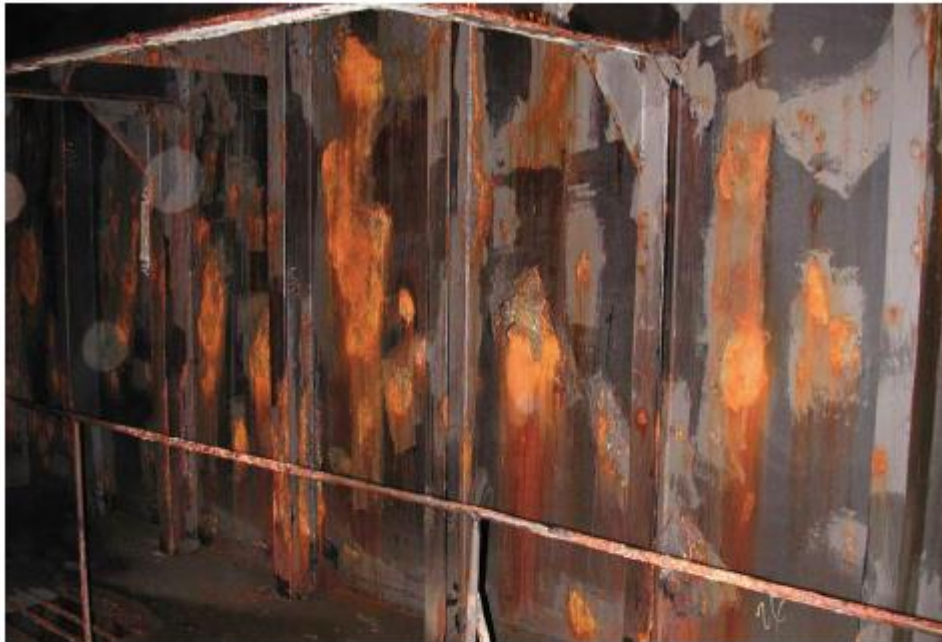
Epoxi en una condición desfavorable

Comentario: Corrosión en superficies planas, en los bordes y soldaduras del 20%

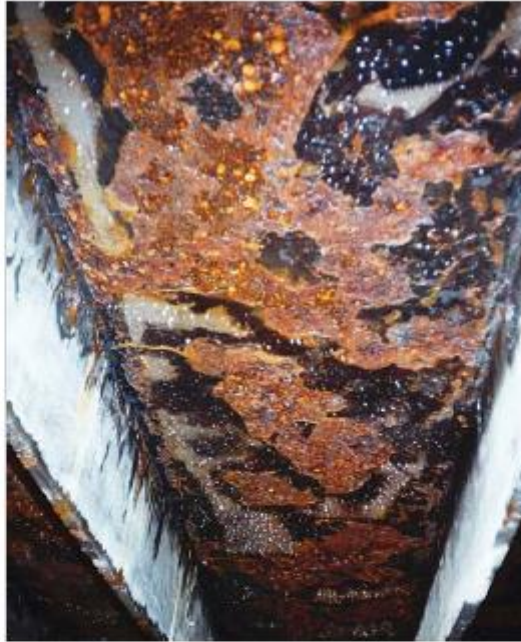
Epoxi en una condición desfavorable

Comentario: Corrosión en superficies planas mayor al 50% y corrosión en los bordes y soldaduras del 20%

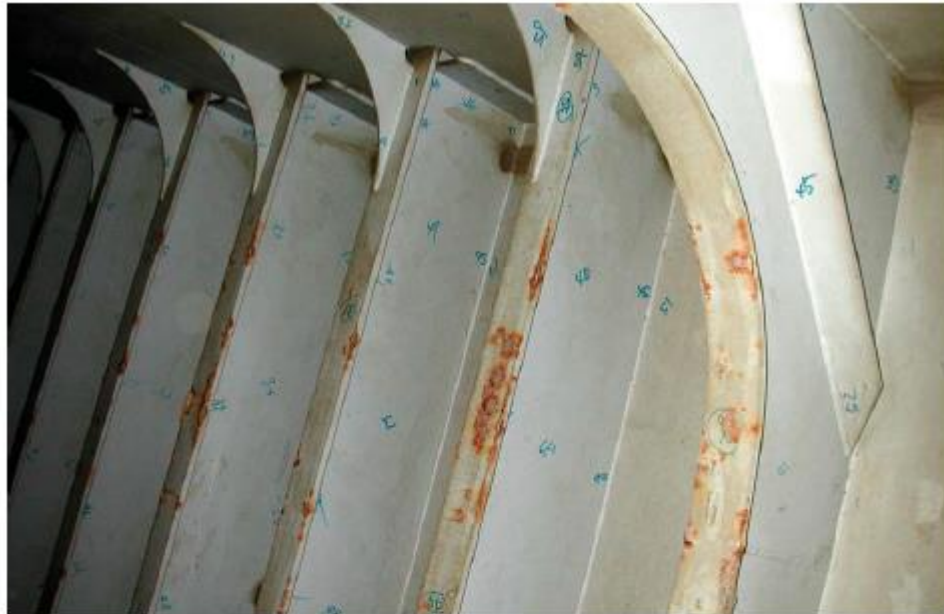
Recubrimiento con color brillante para tanques de lastre en buena condición

Comentario: Corrosión en superficies planas menor al 1% y corrosión en los bordes y soldaduras de entre el 5% y el 10%

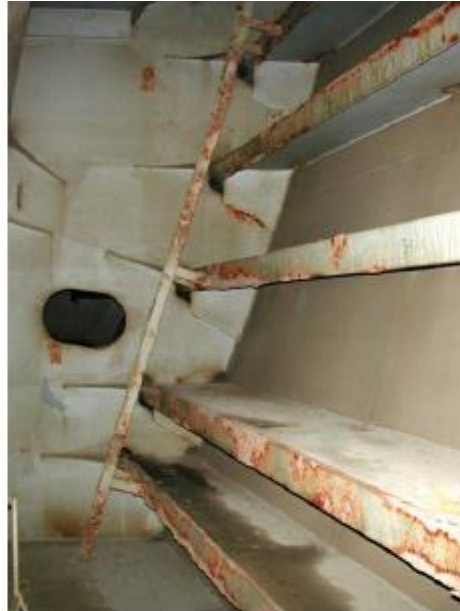
Recubrimiento con color brillante para tanques de lastre en una condición buena/aceptable

Comentario: Corrosión en superficies planas menor al 1% y corrosión en los bordes y soldaduras menor del 20%

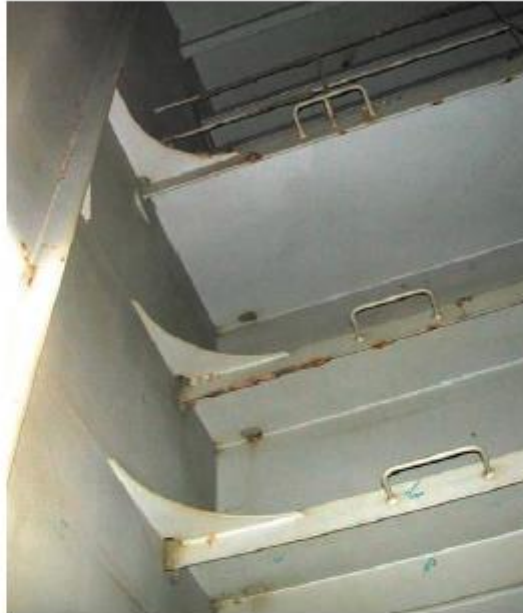
Recubrimiento con color brillante en buena condición

Comentario: Corrosión en superficies planas menor al 1% y corrosión en los bordes y soldaduras menor del 5%

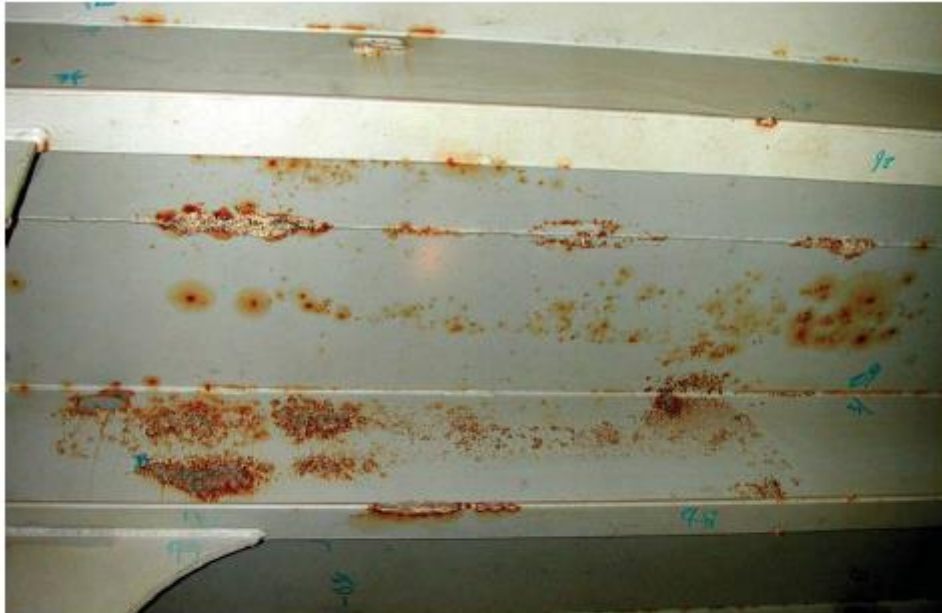
Recubrimiento con color brillante para tanques de lastre en una condición buena/aceptable

Comentario: Corrosión en superficies planas menor al 3% y corrosión en los bordes y soldaduras menor del 10%

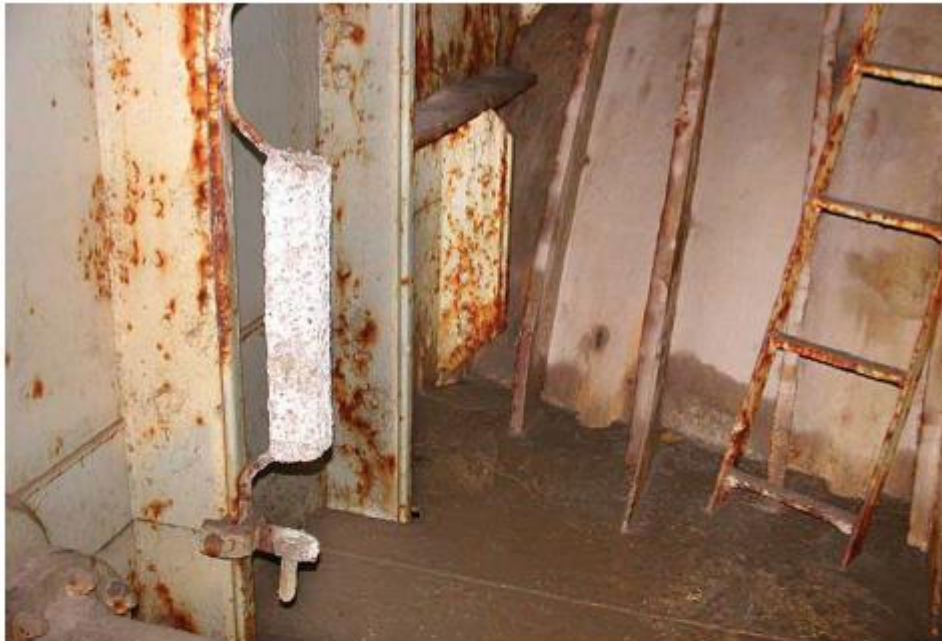
Recubrimiento con color brillante en una condición buena/aceptable

Comentario: Corrosión en superficies planas menor al 5% y corrosión en los bordes y soldaduras menor del 20%

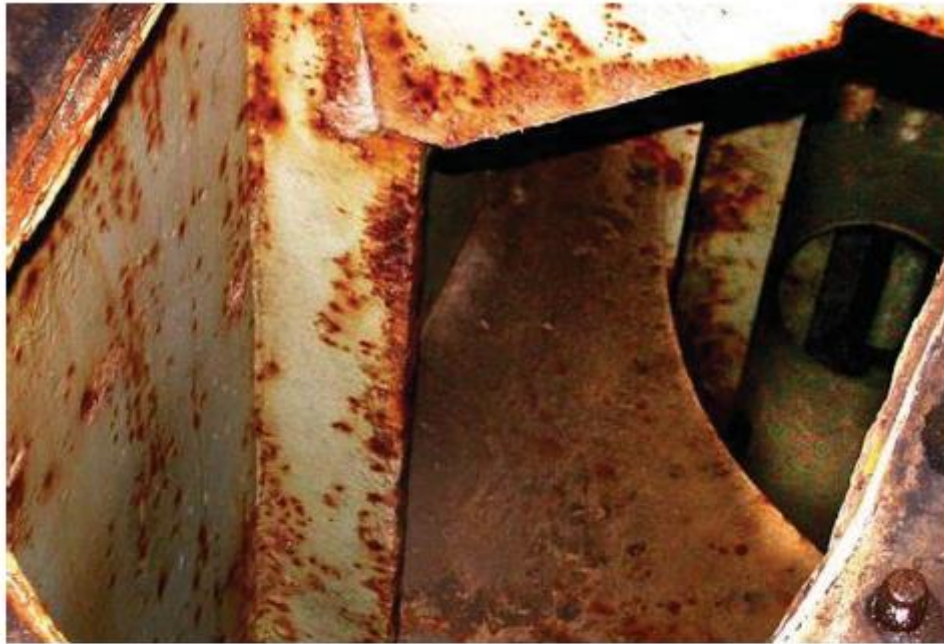
Recubrimiento con color brillante en una condición desfavorable

Comentario: Corrosión en superficies planas mayor al 10% y corrosión en los bordes y soldaduras mayor del 50%

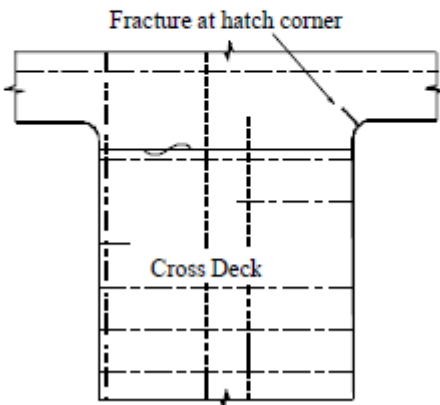
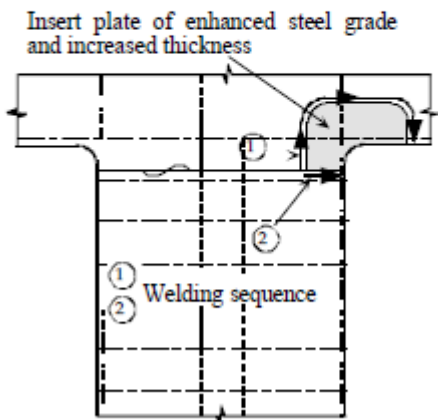
BULK CARRIERS		Guidelines for Surveys, Assessment and Repair of Hull Structure	
Part 1	Cargo hold region	Example No.	
Area 1	Deck structure	1	
Detail of damage		Fractures at main cargo hatch corner	
Sketch of damage		Sketch of repair

Notes on possible cause of damage		Notes on repairs	
<ol style="list-style-type: none">1. Stress concentration at hatch corners, i.e. radius of corner.2. Welded attachment of shedder plate close to edge of hatch corner.3. Wire rope groove.		<ol style="list-style-type: none">1. The corner plating in way of the fracture is to be cropped and renewed. If stress concentration is primary cause, insert plate should be increased thickness, enhanced steel grade and/or improved geometry. Insert plate should be continued beyond the longitudinal and transverse extent of the hatch corner radius ellipse or parabola, and the butt welds to the adjacent deck plating should be located well clear of the butts in the hatch coaming. It is recommended that the edges of the insert plate and the butt welds connecting the insert plates to the surrounding deck plating be made smooth by grinding. In this respect caution should be taken to ensure that the micro grooves of the grinding are parallel to the plate edge.2. If the cause of fracture is welded attachment of shedder plate, the deck connection should be left unwelded.3. If the cause of the fracture is wire rope groove, replacement to the original design can be accepted.
